AEAS Report Number 13

Engineering Report on the Replacement Source

Engineering Report on the Kaneohe Replacement Source

ENGINEERING REPORT -- KANEOHE REPLACEMENT SOURCE

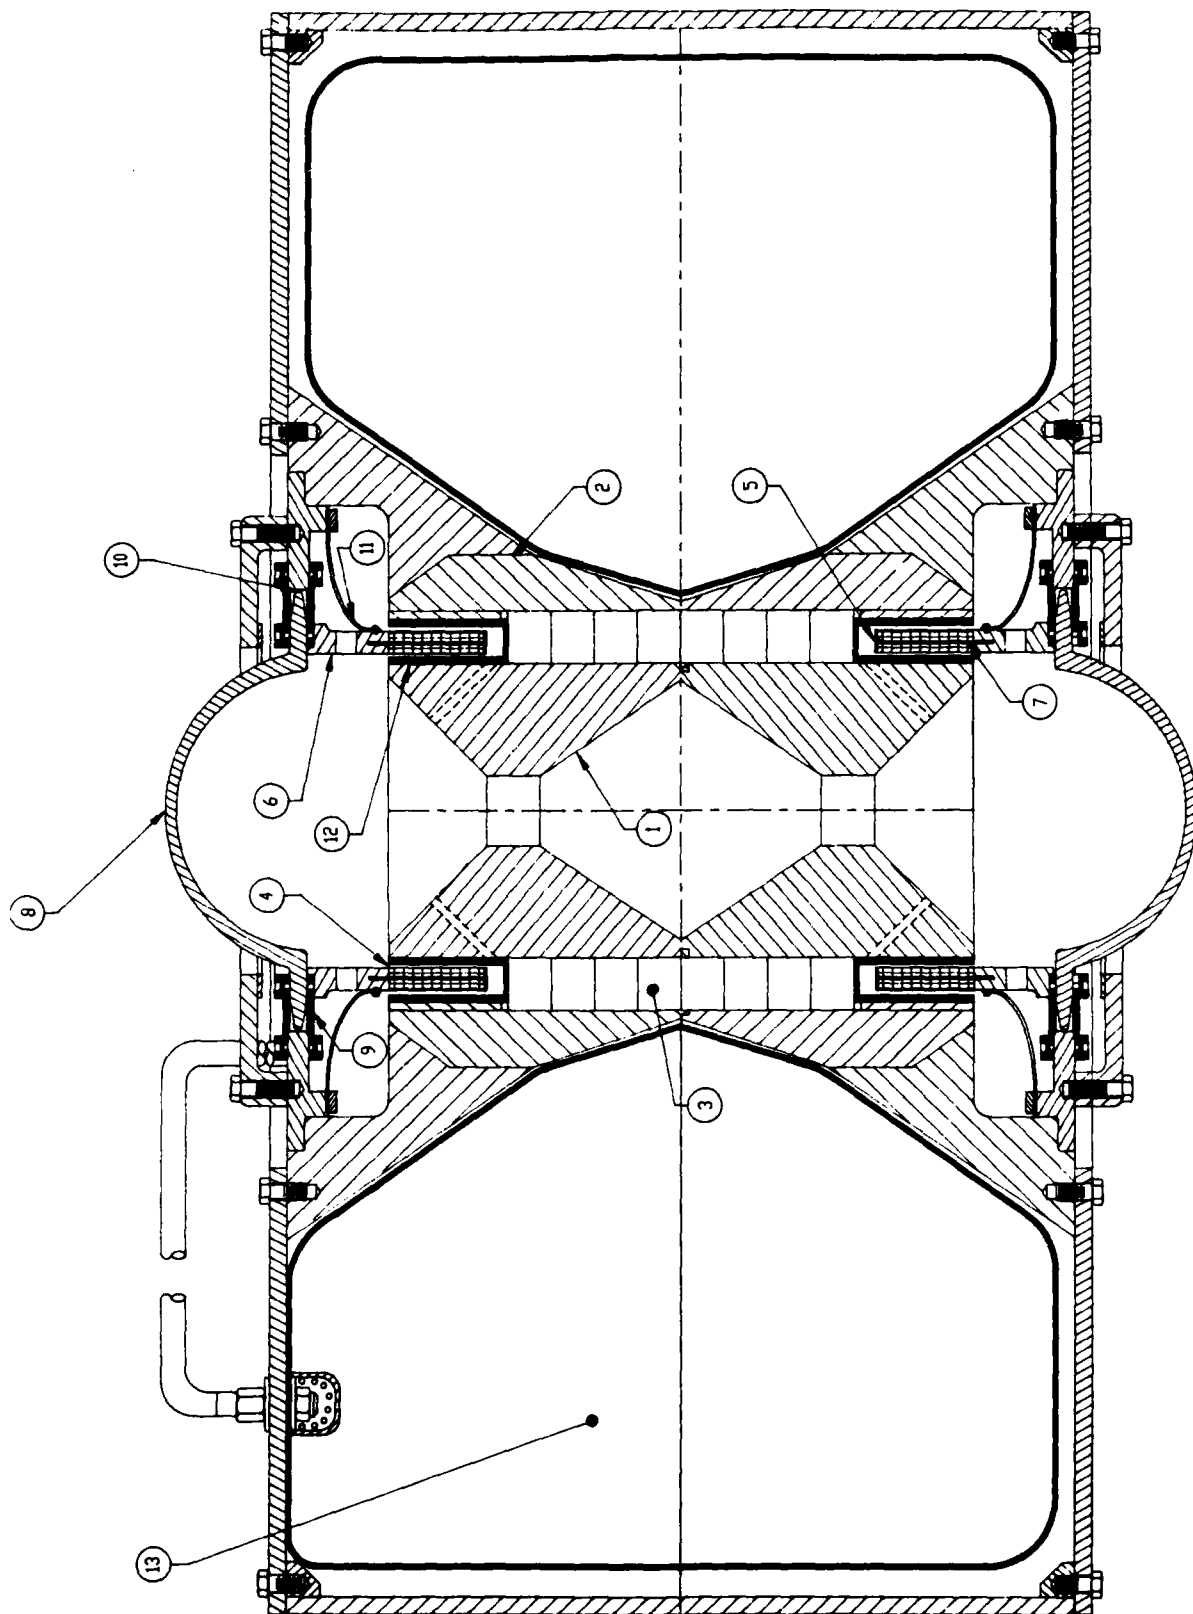
Figure 1. The Model KN-1 Kaneohe Source

After the transducer is installed, the air chamber (13) is compressed, and that volume is then filled with water, so that dissipation of the thermal load is also aided by the increased water contact with the magnet/body.

Electrical conductors to the coils (not shown) are also oil filled, and are at zero differential pressure; these leads are connected to the transformer, which is also at ambient pressure. The main signal cable from shore is connected to the transformer input terminals, and the cable is mated to the support platform for mechanical strength. Figure 2 is the electrical circuit diagram connecting the dry-end power amplifier/transformer through the cable to the transducer/transformer unit located on the bottom. Based on the earlier site survey, it was recommended that the dry-end power amplifier and transformer be replaced if the full acoustic power output was desired; some concern was expressed that the amplifier and transformer, which were designed for bender bar transducers, should be replaced as being marginal in capability.

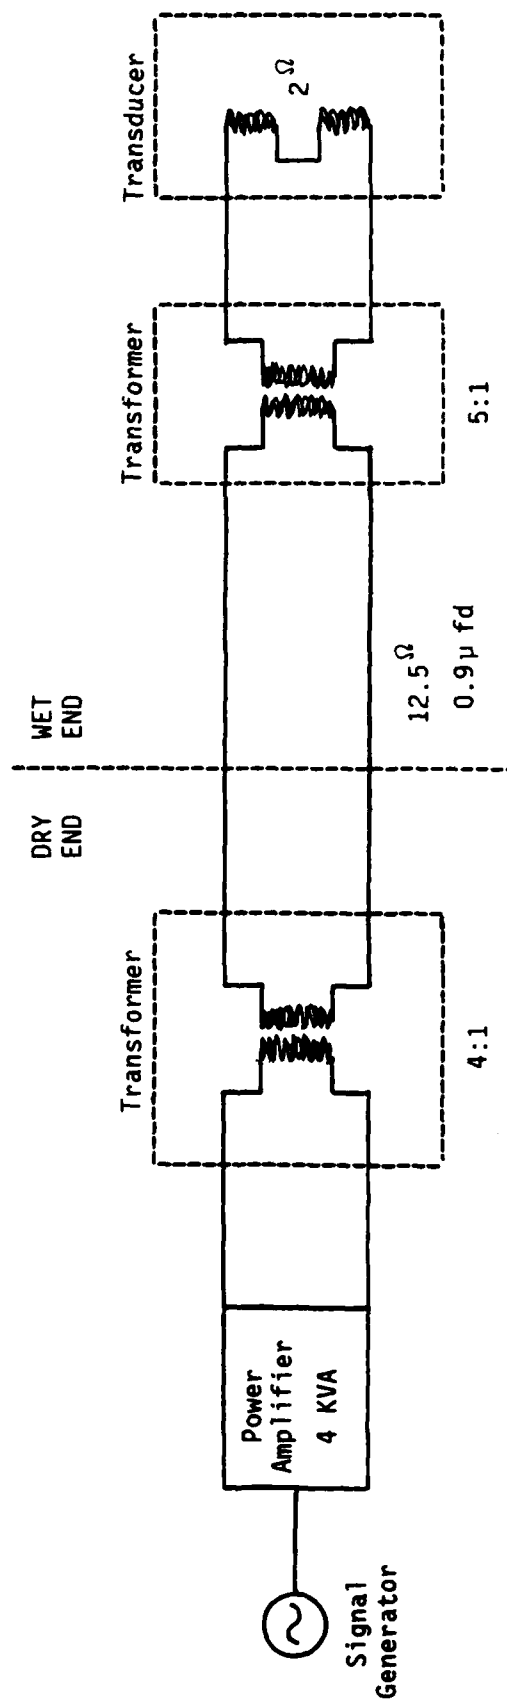
Figure 2. Kaneohe Source Circuit Diagram

During construction, the wet-end transformer suffered insulation damage, and failed after 90 hours of operation. The transformer was replaced with a new transformer; the turns ratio was reduced from 6.45:1 to 5:1, to more closely match the replacement transformer on the dry-end, a 4:1 turns ratio.

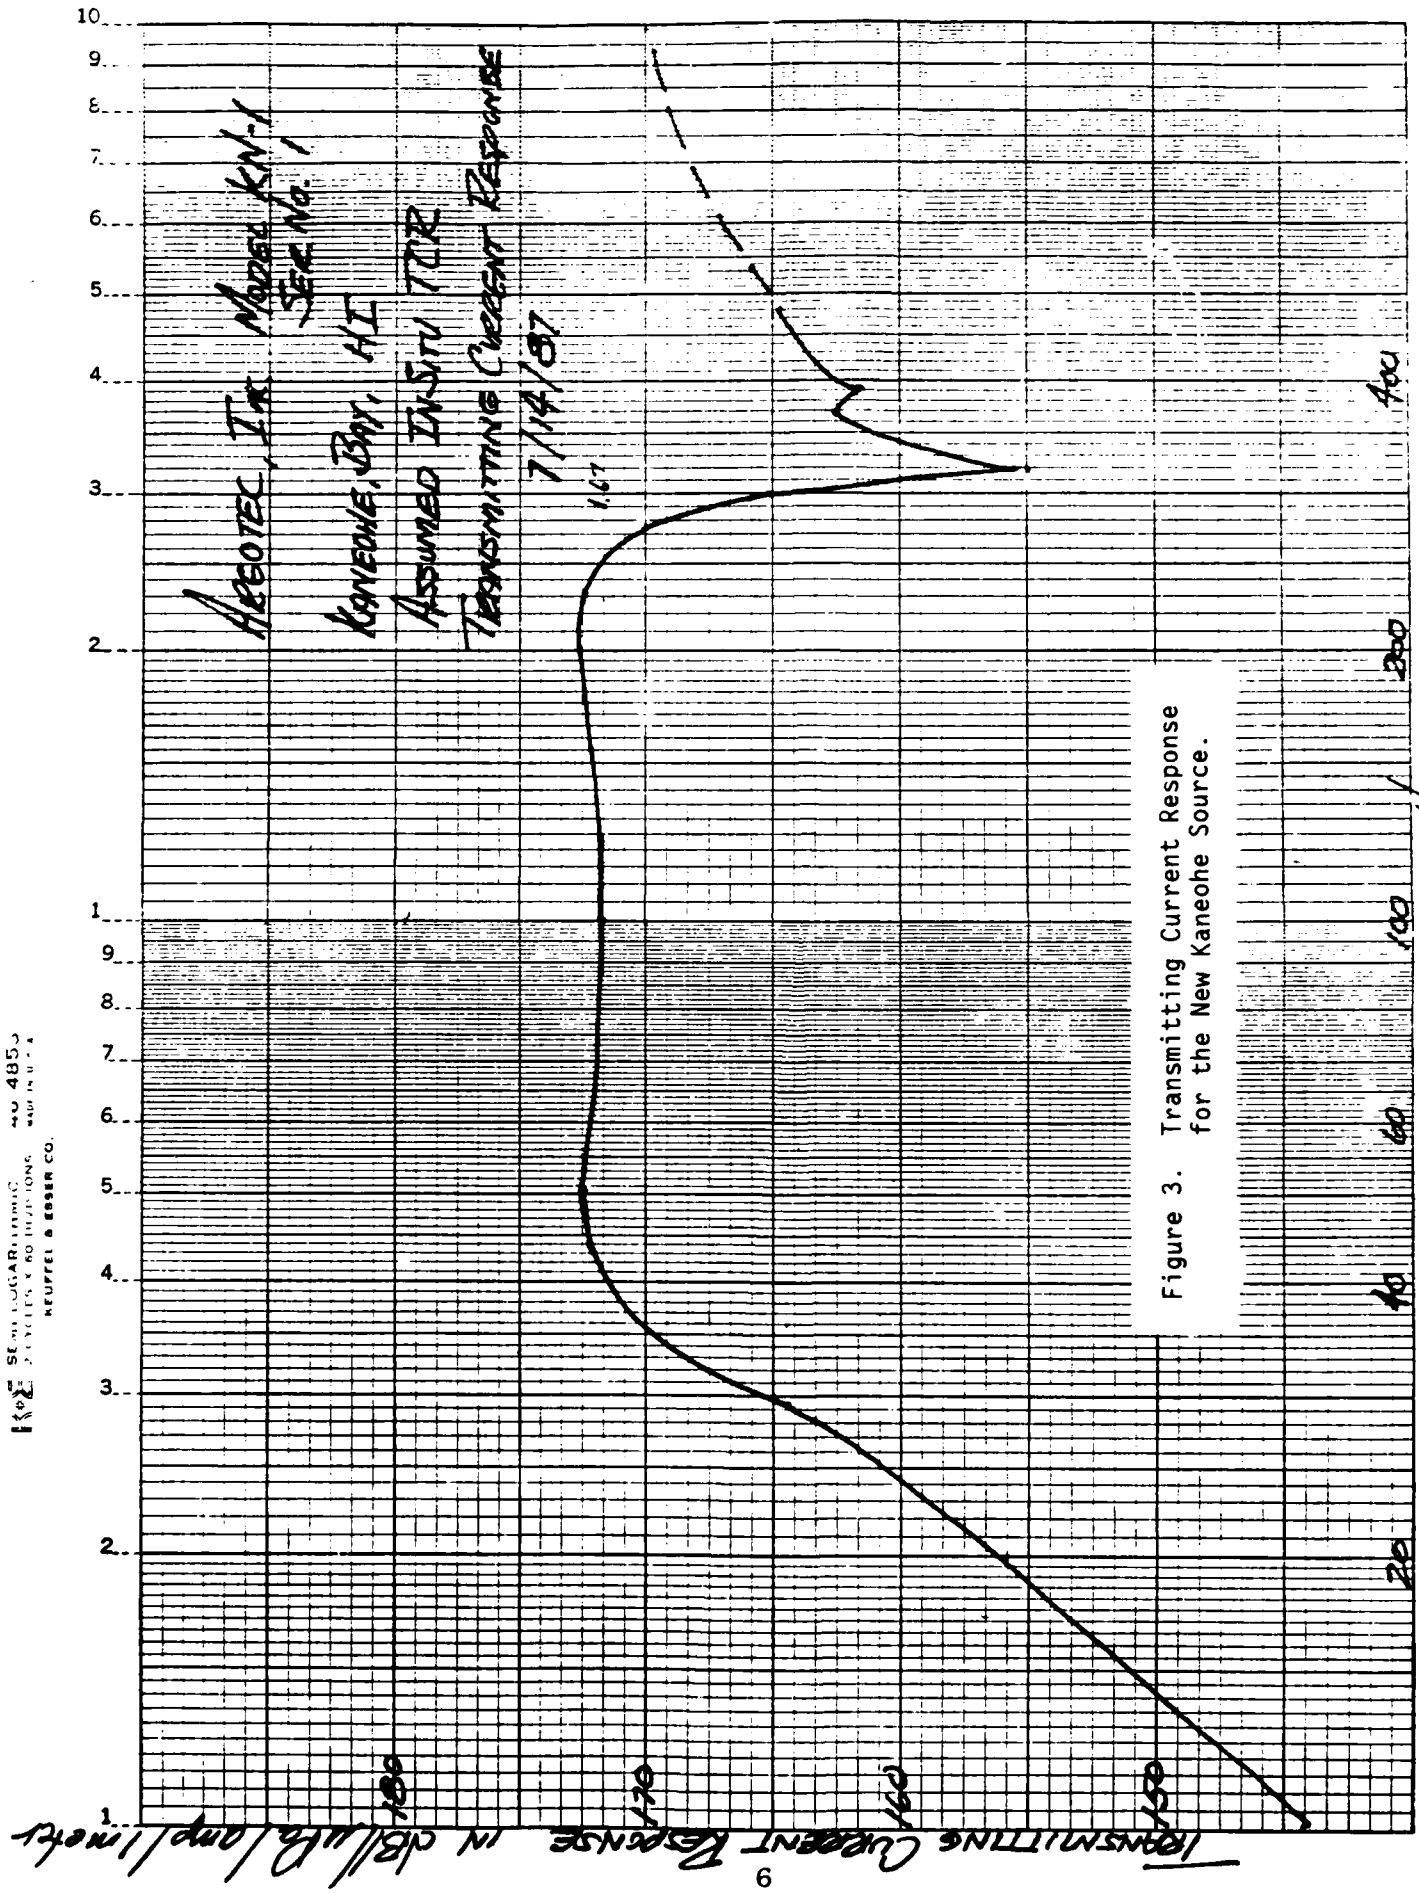
Figure 3. Transmitting Current Response for the New Kanehoe Source.

The electro-acoustic properties shown in these tables and curves will provide the necessary data base to change or modify the power amplifier and the drive signal frequency to obtain desired response in output sound pressure level. If changes are made to the cable, or the errors in earlier measurements are noted, then the TCR for the system must be re-developed.

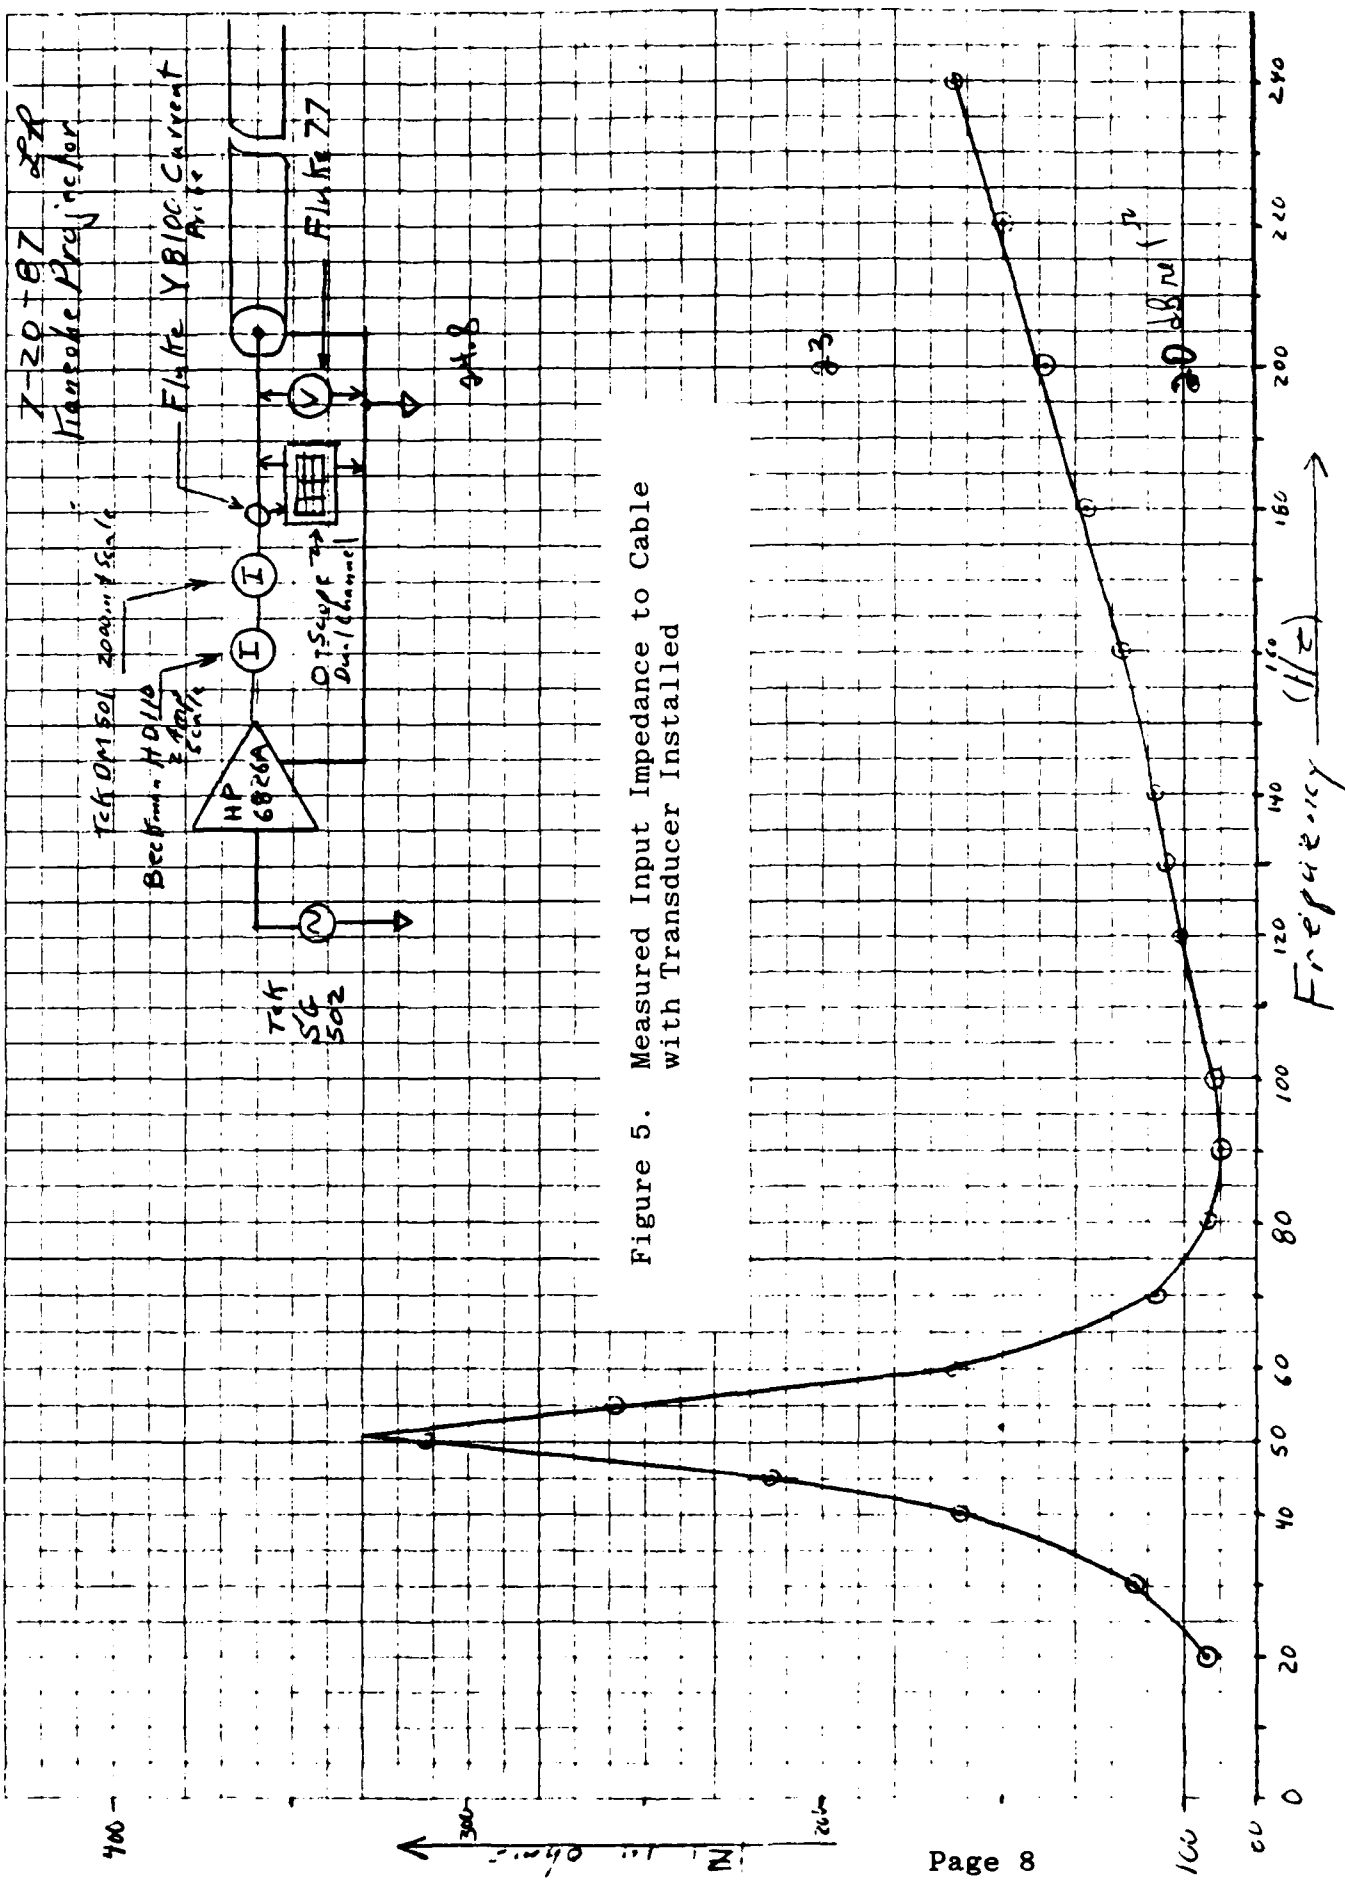
Figure 5. Measured Input Impedance to Cable with Transducer Installed

Table 1. Cable/Transducer Impedance Measurements vs Frequency

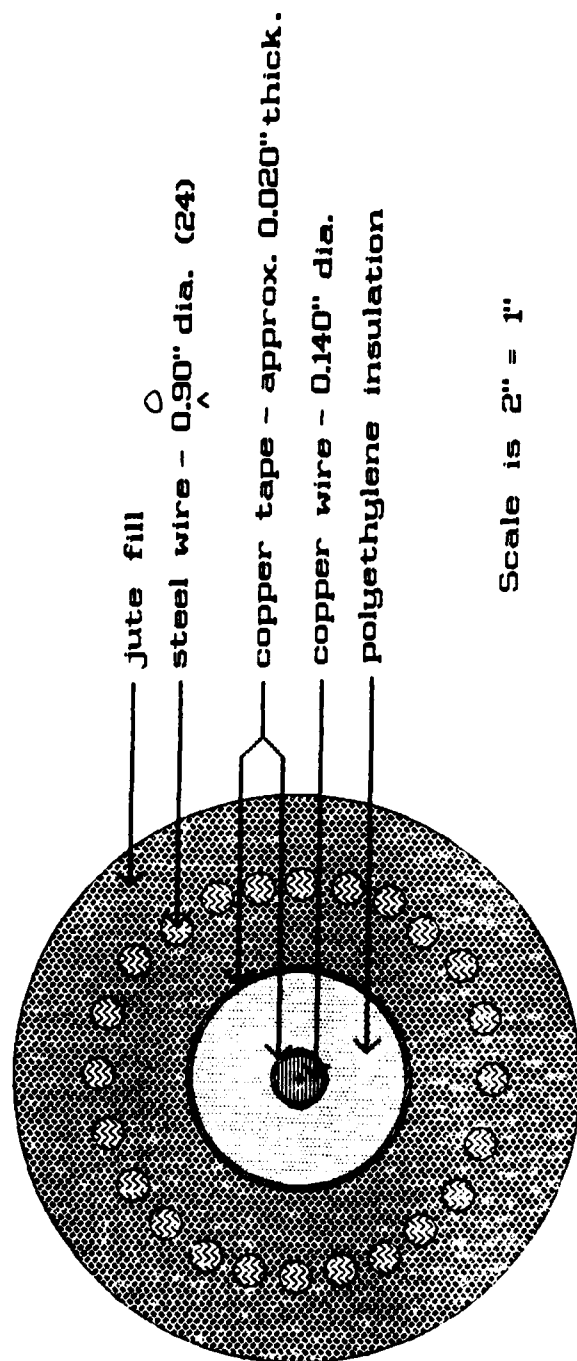
Figure 7. Physical Characteristics of Sea Cable

Figure 7 indicates the construction features of the single armored sea cable; the double armored cable has a similar steel wire outer armor, and is used during the first 1,000-foot section from the transducer toward shore. A summary of the major sea cable properties is included in Table 2. Note that the double armor provides the extra strength necessary to recover the source by the signal (sea) cable.

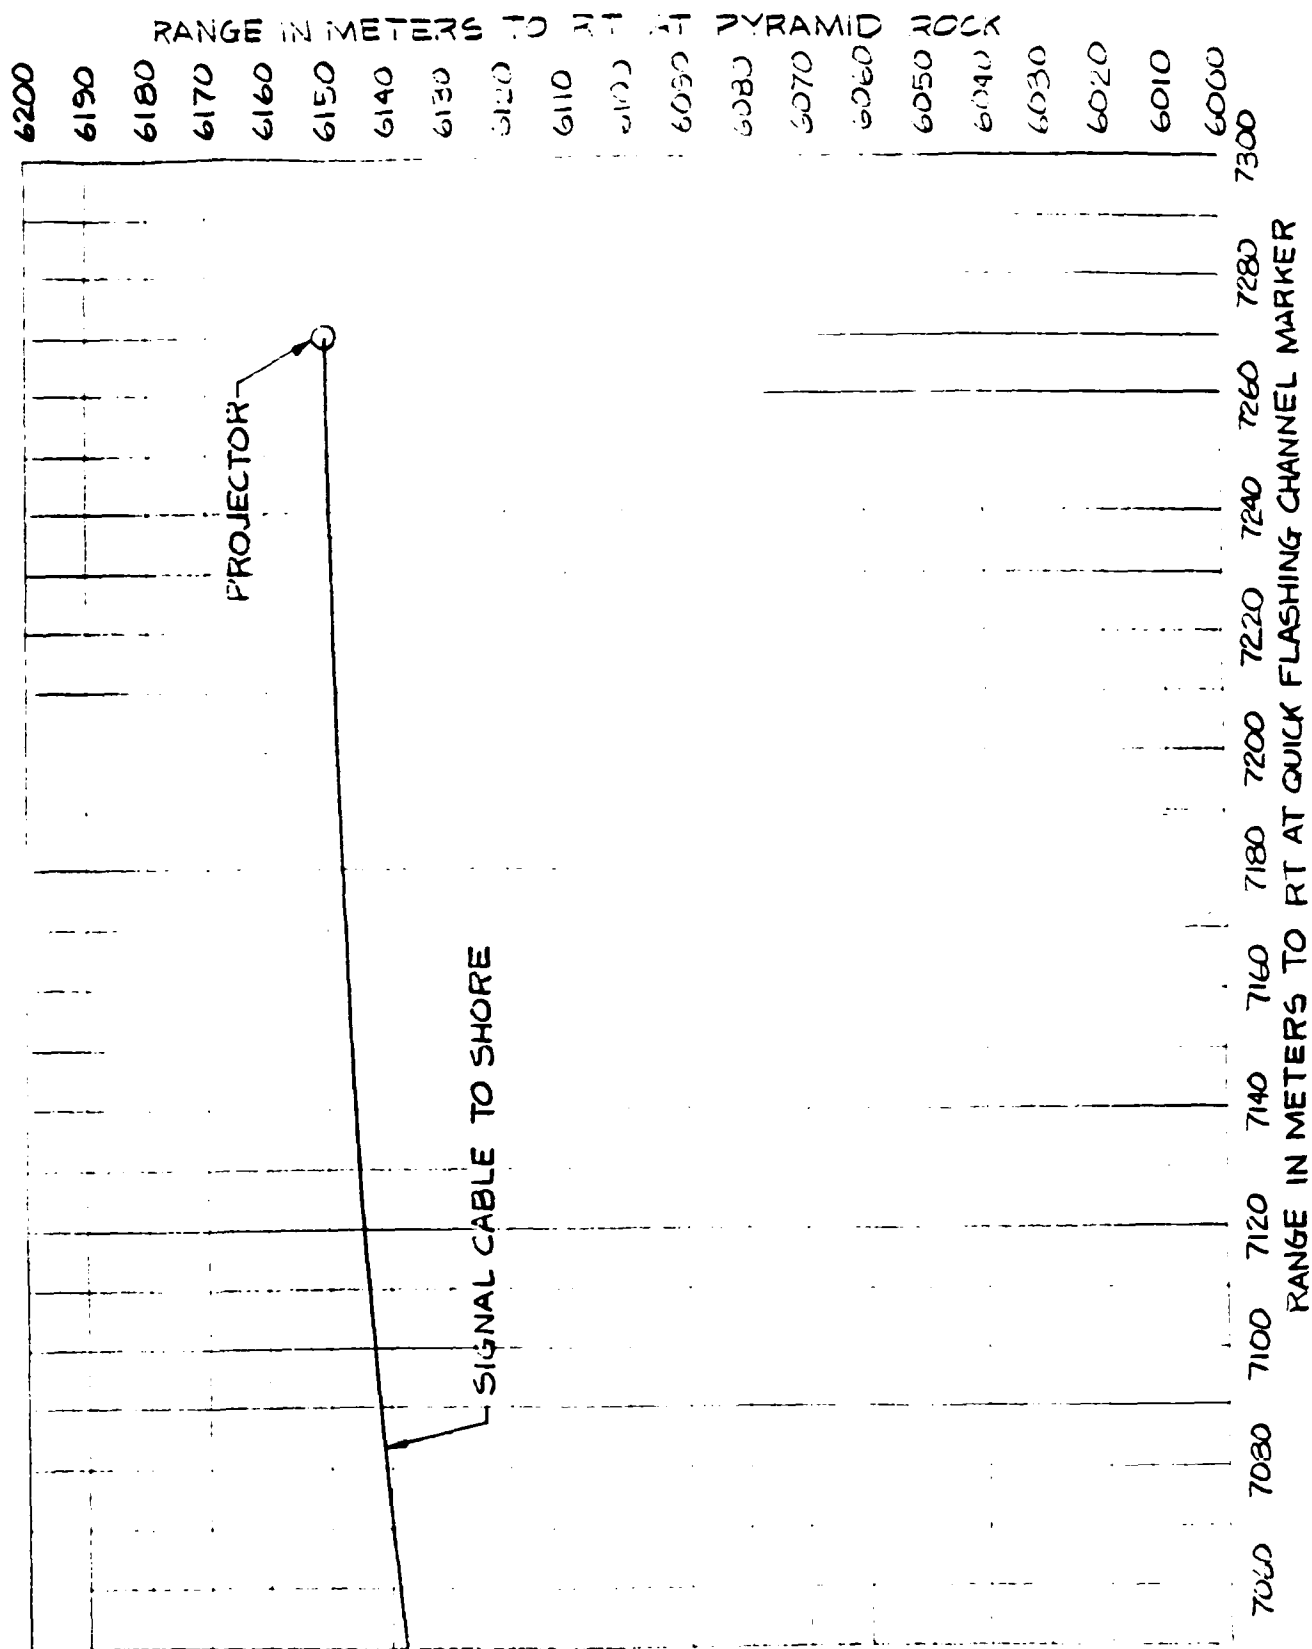
FIGURE 1-2

Figure 1-2 shows the predicted range/range grid in the location of the projector. Relative accuracy is estimated at ± 50 feet, although greater deviation is possible. Absolute geodetic accuracy is not known. Commonly accepted coordinates for the projector are $21^{\circ}30.97\text{N}$ and $57^{\circ}46.44\text{W}$.

MINIRANGER NAVIGATION GRID

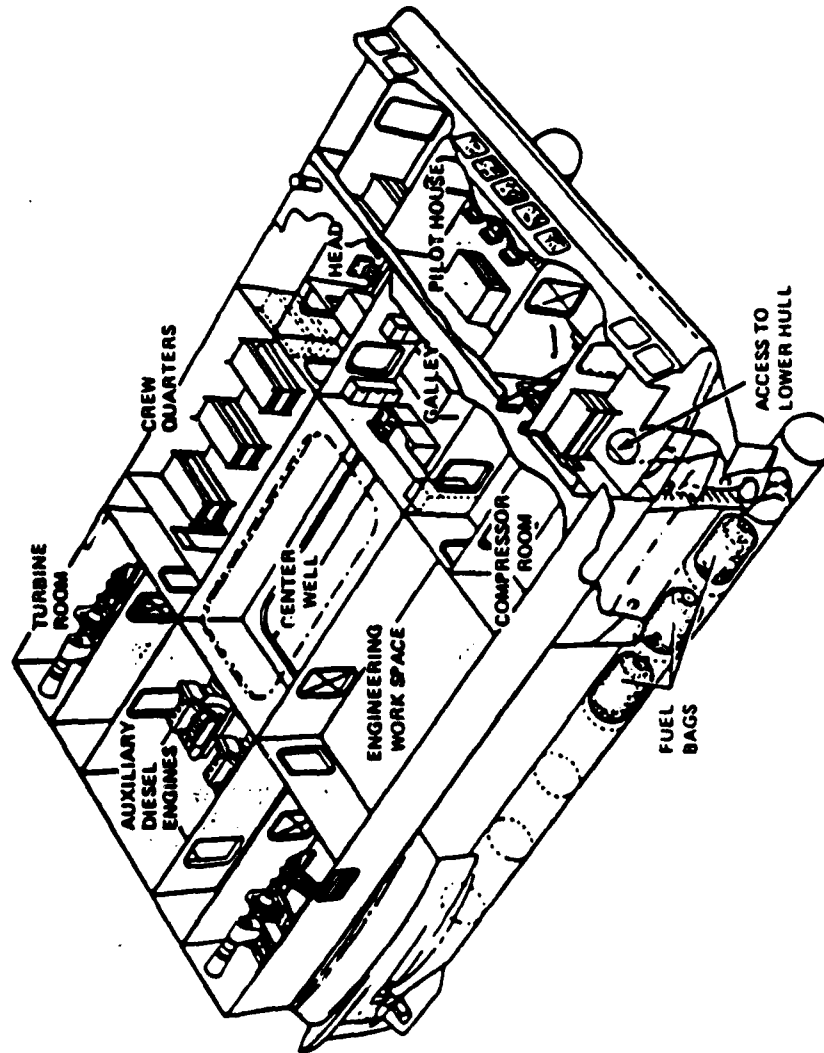
Figure 2-1

SSP KAIMALINO DECK LAYOUT

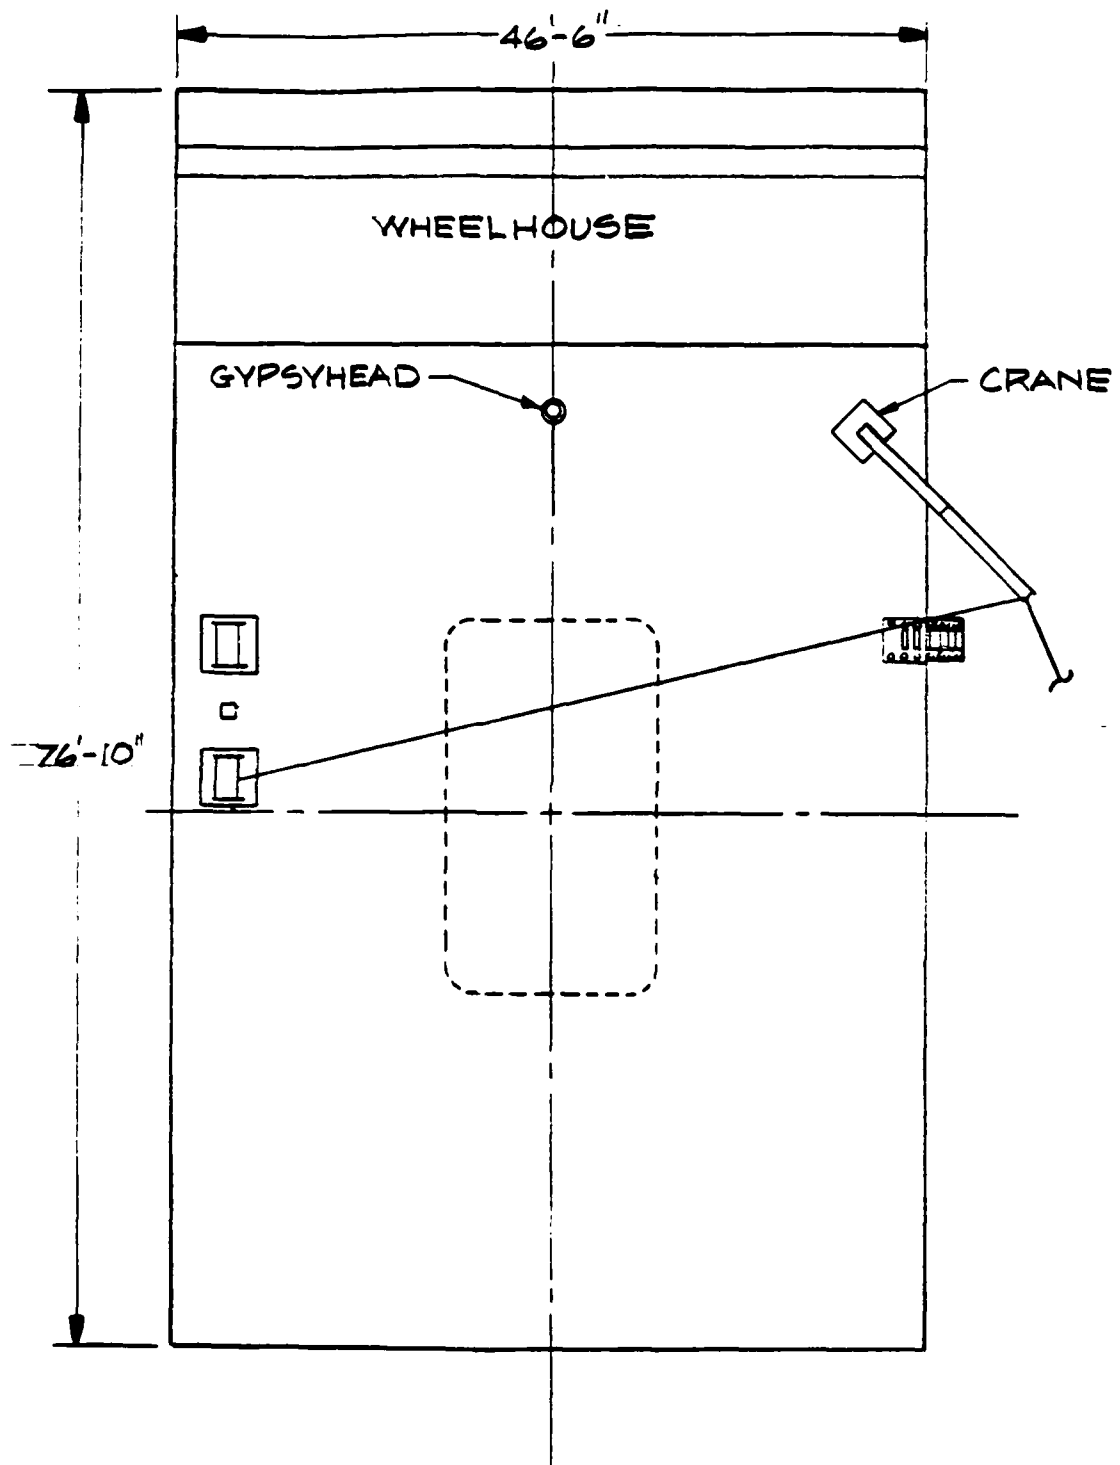
SNATCH BLOCK ON CRANE USED
TO OVERBOARD GRAPPLE LINE
FIGURE 3-1

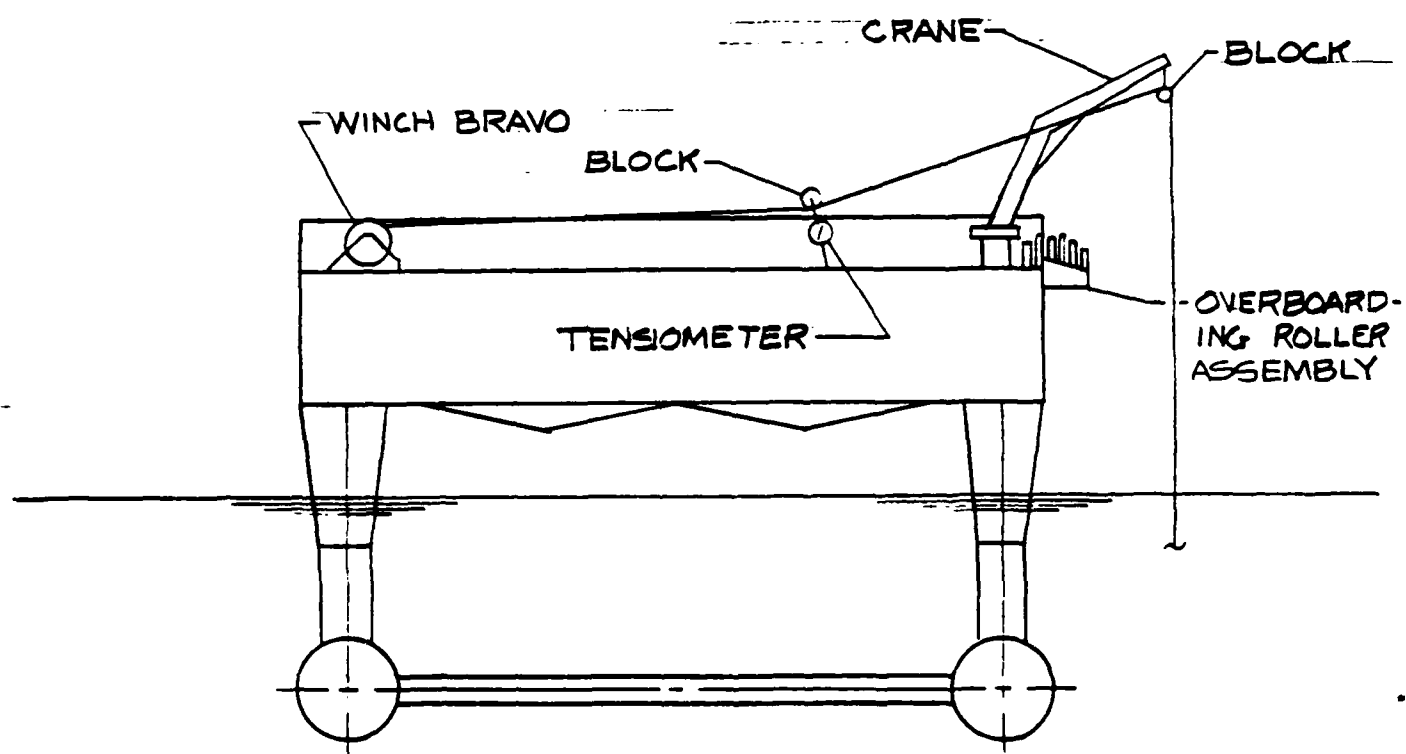
VIEW SHOWING SPRING SCALE OR
TENSIMETER RIGGED BETWEEN SNATCH
BLOCK RIDING ON GRAPPLE LINE AND DECK PADEYE
FIGURE 3-2

The spring scale will be closely monitored during all runs. When tension increases indicating entrapment of the grapple line, the vessel will be stopped, position noted and recovery begun.

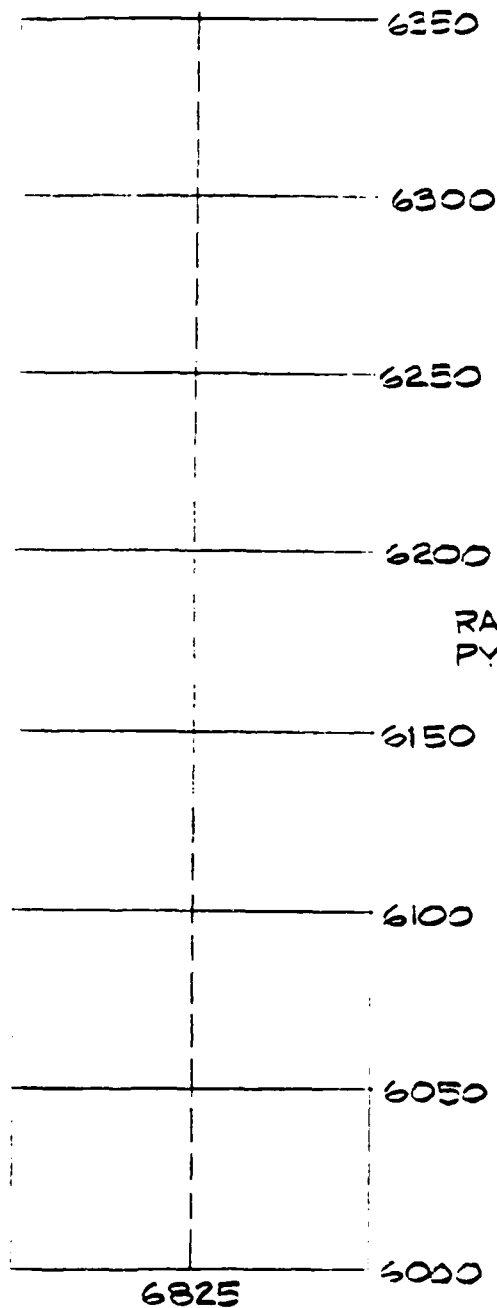
Once the tensiometer is rigged, the vessel is ready to begin dragging. Figure 3-3 shows the first dragging trackline. Successive drag tracklines will be determined on site, depending upon currents, sea conditions, grapple line scope, etc.

RANGE TO RT AT
QUICK FLASHING
CHANNEL MARKER
GRAPPLE TRACK LINE
RANGE IN METERS
FIGURE 3-3

The initial trackline was refined after the SSP KAIMALINO Captain found better polypropylene line coordinates in his log book. The trackline followed started at A: 6800, B: 5800 and proceeded along the 6800 line until the B changed to 6050. The polypro grapple line was ensnared on the first drag at B equal to 5980.

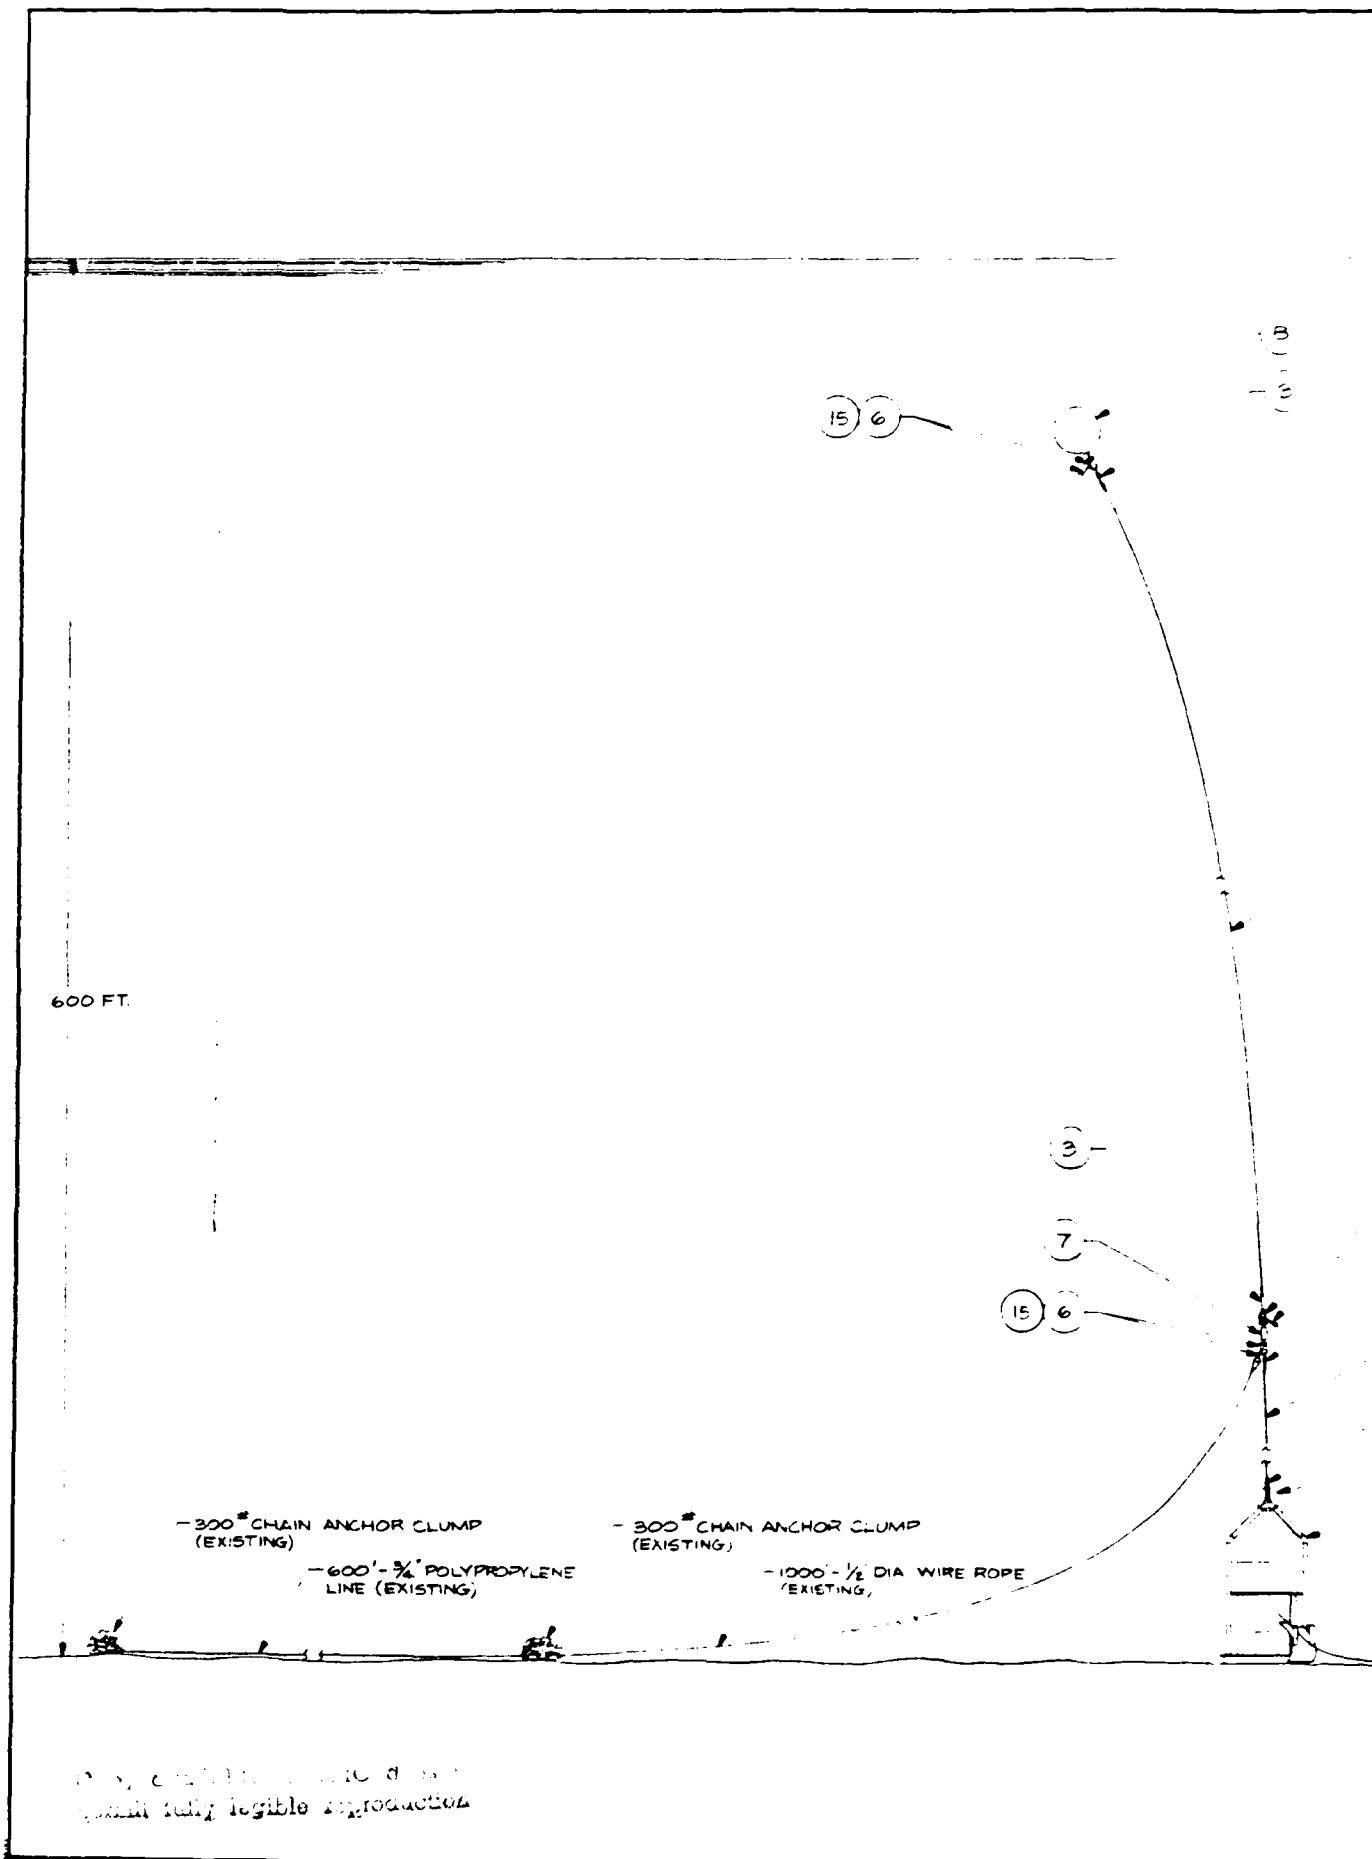
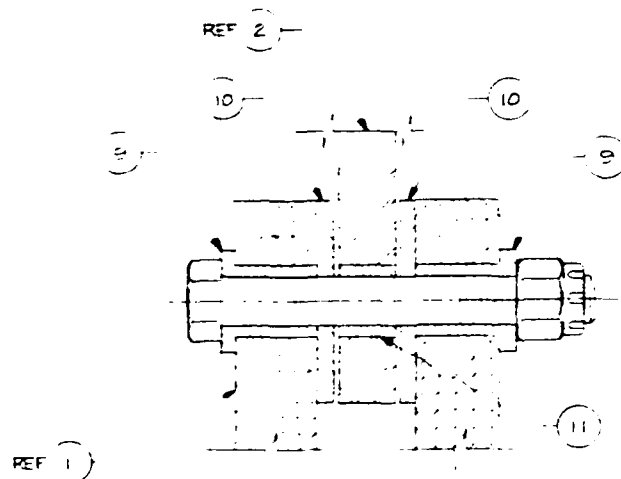
NO.	DESCRIPTION	QTY
1	PROJECTOR STAND ASSY	1

The replacement projector and stand are shown in Tracor Marine Drawing #D0701251-001. The air weight of the assembly is approximately 3,000 pounds. Cable tension at the surface is estimated to be 600 pounds. Total overboarding weight will be the summation; 3,600 pounds.

DETAIL A
SCALE 1:1
